WO #FEMA 5775  
MODS TO B-137 FRCE  
SCANNER ROOM

AMENDMENT #0002

# **LEAD PAINT AND ASBESTOS SURVEY**

**Marine Corps Air Station – Cherry Point  
Fleet Readiness Center East  
Building 137 Photography Laboratory  
FEMA Project 5775  
Facility Modification for New Scanner  
Cherry Point, North Carolina**

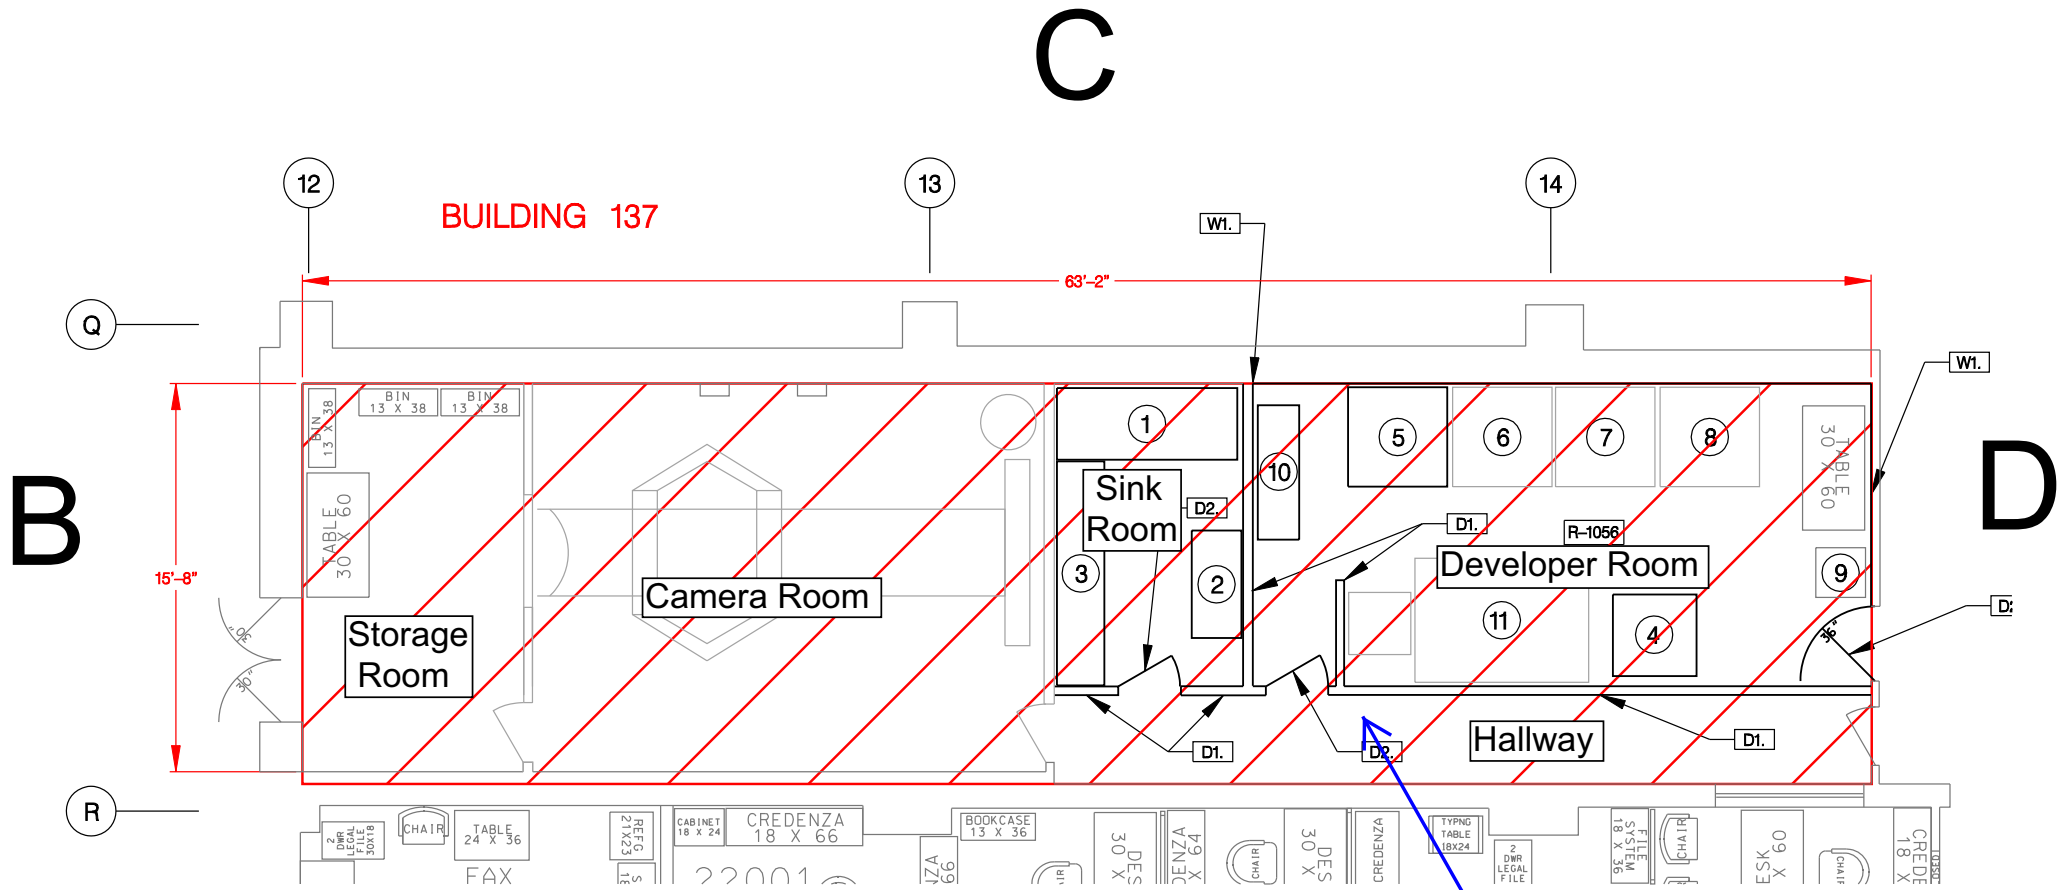
Figure 2: Lead Survey Reference Map  
 MCAS - Cherry Point  
 Building 137 - Photo Lab  
 Lead Paint Survey  
 July 2011

As indicated on the lead paint field testing sheets, lead paint  $>1.0$  mg/cm<sup>2</sup> was **not** detected in the Photography Laboratory in Building 137.

The highest concentrations of lead in paint were found on the overhead sprinkler pipe in the developer room (XRF test #17) the developer room ceiling (XRF test #16), the hallway upper wall, baseboard and ceiling (XRF test #23, 24 & 28) and the camera room ceiling (XRF test #62) and the results ranged from 0.11 to 0.29 mg/cm<sup>2</sup>. A list of all the test locations with the XRF results is included on the field sheets in **Appendix I**.

As indicated in the laboratory report the paint chip sample collected from the hallway ceiling contained 0.014 percent lead by weight; however, the detected amount does not exceed the EPA action level of 0.5 percent by weight. According to 24 CFR Subtitle A, lead-based paint means paint or other surface coatings that contain lead equal to or exceeding 0.5 percent by weight. The amount of lead detected in the paint chip sample does not exceed.

LBP#01 - Hallway Ceiling  
 0.014% by weight

Although no lead paint greater than 1.0 mg/cm<sup>2</sup> was detected in the test area, it should be noted that during renovation or demolition, disturbing paint which contains lead in amounts less than 1.0 mg/cm<sup>2</sup> may release dust which could exceed acceptable levels. Prior to renovation or maintenance activities which could disturb paint containing any amount of lead, worker safety should be addressed. The OSHA construction safety standards for lead-based paint (29CFR 1926.62) includes guidelines for worker safety. If demolition or renovation planned for components of the area that include paint containing lead, the paint or painted components may need to be removed by an NC licensed lead abatement contractor prior to the beginning the work.

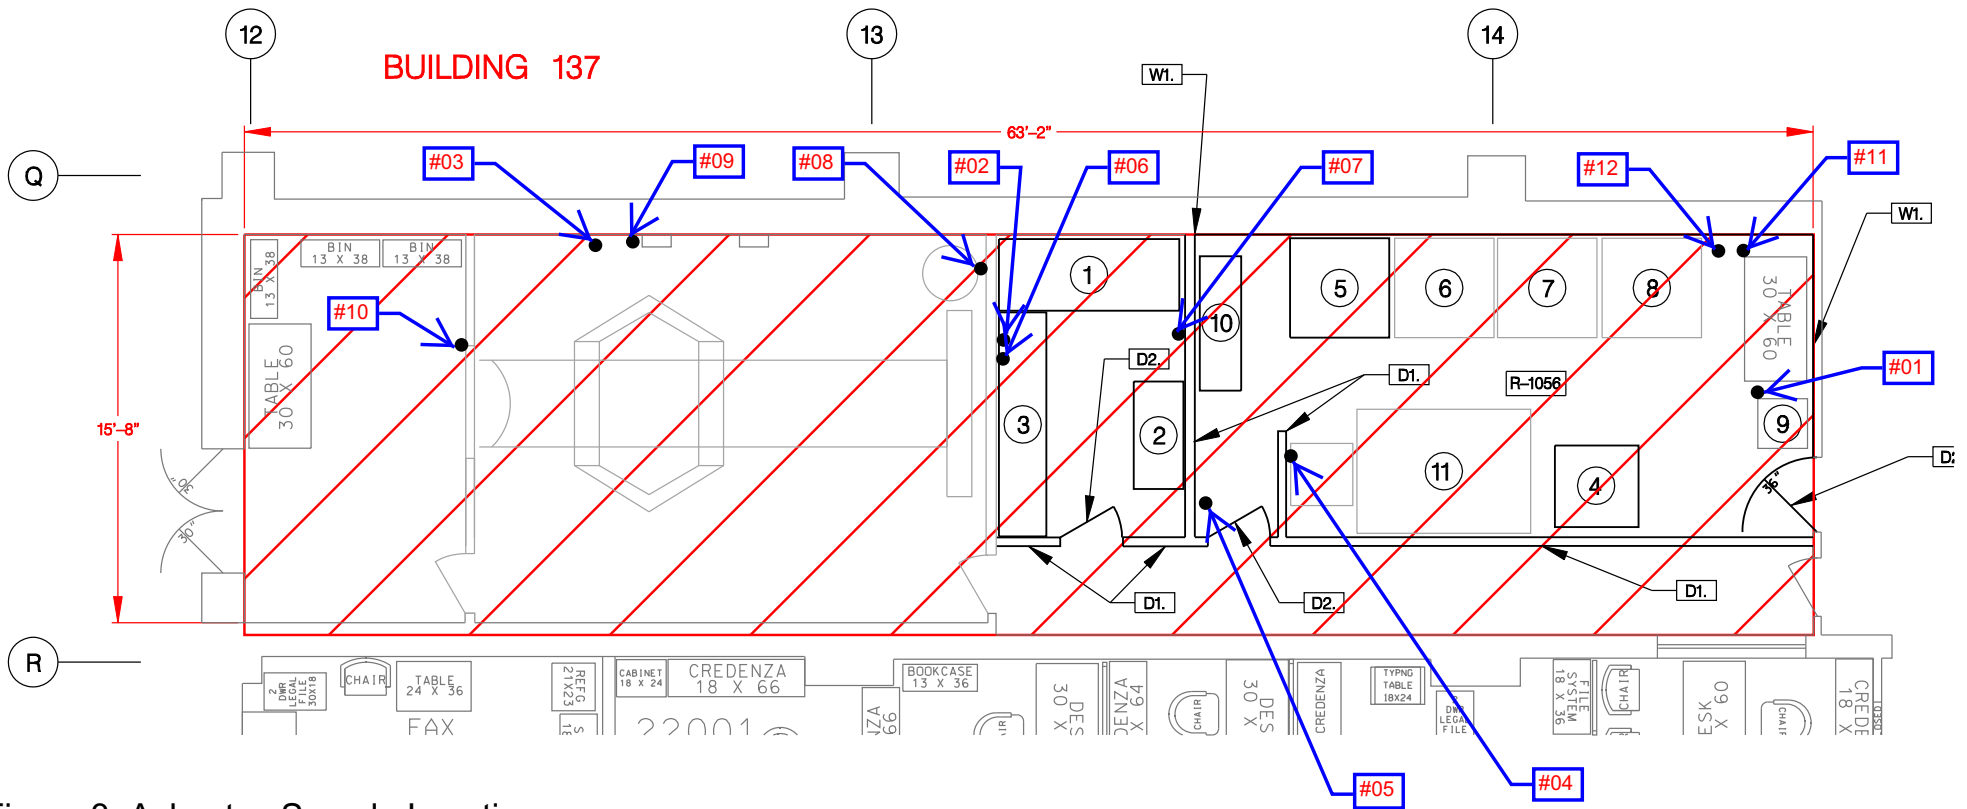
Figure 3: Asbestos Sample Locations  
 MCAS - Cherry Point  
 Building 137 - Photo Lab  
 Lead Paint Survey  
 July 2011

On June 30, 2011, Pyramid conducted an asbestos survey at the above-referenced property. The samples were collected by Brett Higgins, a North Carolina accredited asbestos inspector (License #11110). Representative samples of suspect asbestos containing materials (ACMs) were collected, and included: roll-out floor covering, two types of wallboard, and the outer covering of the overhead HVAC duct work. The area was visually and physically inspected and no other suspected ACMs were identified. Twelve (12) samples of suspect ACMs were collected for laboratory analysis. The sample locations are shown on **Figure 3**.

Based on the asbestos laboratory report, the only material that contained greater than 1 percent asbestos is the tan and brown roll-out floor covering. The three samples of the roll-out floor covering that were collected contained 10% chrysotile asbestos. The flooring was observed throughout the entire area and measures approximately 1,000 square feet.

As indicated on the lab report, the lab was unable to separate the mastic on the roll-out floor covering (#01, #02 & #03). According to a lab representative, the samples contained an adequate amount of mastic to perform a separate test; however the asbestos containing backing on the flooring was mixed with the mastic and there was no way of determining if the asbestos fibers were coming from the mastic or the flooring.

The same thing is likely to happen when the asbestos removal contractor removes the flooring. The positive backing from the flooring is going to stay adhered to the mastic and will be very difficult to separate.

The laboratory results of the asbestos survey indicate that approximately 1,000 square feet of asbestos containing roll-out floor covering and mastic is present in the Building 137 Photography Lab. The area containing the asbestos floor covering begins at a wall approximately 12 feet 9.6 inches southwest of columns R14 and Q14 and extends northeast 63 feet 2 inches to columns R12 and Q12 and measures 15 feet 8 inches wide.

In this case Pyramid recommends that we should assume the mastic is positive because it will most likely include asbestos fibers from the backing on the roll-out flooring.

Pyramid recommends proper removal and disposal of the asbestos-containing floor covering and mastic by an accredited asbestos contractor. A permit is required for the removal of more than 35 cubic feet, 160 square feet, or 260 linear feet of friable asbestos containing material or non-friable asbestos containing material that may become friable during handling (15 NCAC, Subchapter 19C, Section .0605).
